## CITY OF BALTIMORE SMOKE TESTING OBSERVATION SUMMARY **OUTFALL SEWERSHED BALTIMORE CITY PROJECT 1039** REI/DRAYCO

Unique Test ID: S1039-003 Date: 09/29/2008 Manhole ID: S51II\_003MH

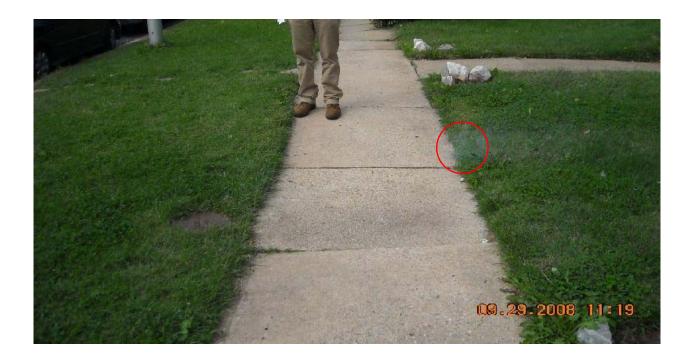
Photograph No: OB01-P01 Filename: S1039-003\_OB01-P01.jpg

Location: 05 Sidewalk Severity: 03 Moderate Drainage Area: 4 ft<sup>2</sup>
Comments: Smoke is coming from the edge of the sidewalk closest to 2624 E. Federal St. along service line.

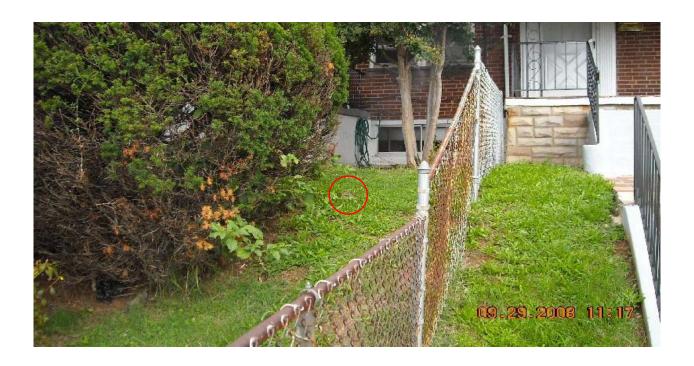
Photograph No: OB02-P01 Filename: S1039-003\_OB02-P01.jpg

Location: 07 Yard - Front Severity: 03 Moderate Drainage Area: 1 ft<sup>2</sup>

Comments: The above grade cleanout in front lawn has a broken cap.

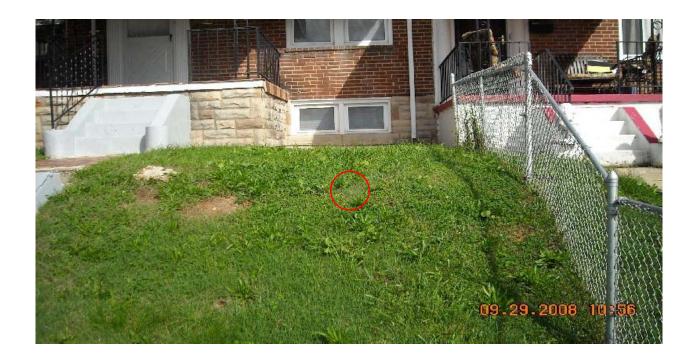
Photograph No: OB03-P01 Filename: S1039-003\_OB03-P01.jpg

Location: 07 Yard - Front Severity: 03 Moderate Drainage Area: 4 ft<sup>2</sup>

Comments: The below grade cleanout in the front lawn is missing a cap.

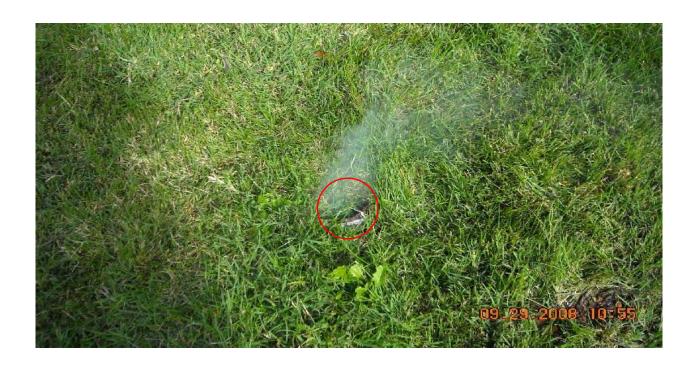
Photograph No: OB04-P01 Filename: S1039-003\_OB04-P01.jpg

Location: 07 Yard - Front Severity: 03 Moderate Drainage Area: 1 ft<sup>2</sup>

Comments: Above grade cleanout in front lawn has a broken cap.

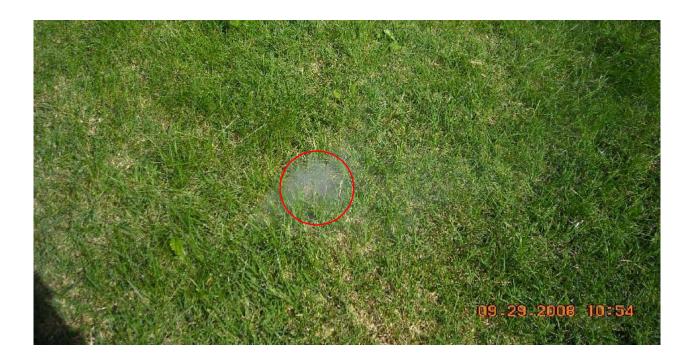
Photograph No: OB05-P01 Filename: S1039-003\_OB05-P01.jpg

Location: 07 Yard - Front Severity: 03 Moderate Drainage Area: 1 ft<sup>2</sup>

Comments: Below grade cleanout in front lawn has a broken cap.

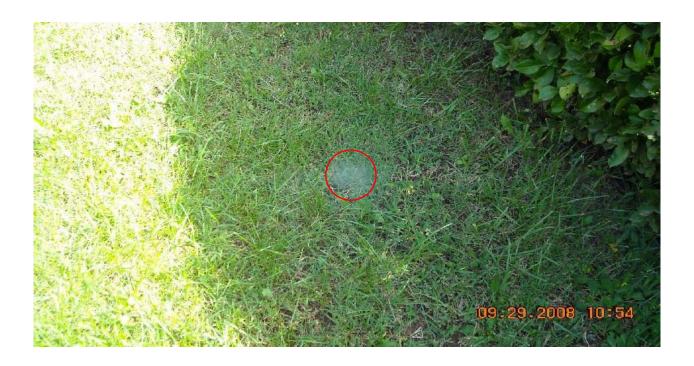
Photograph No: OB06-P01 Filename: S1039-003\_OB06-P01.jpg

Location: 07 Yard - Front Severity: 03 Moderate Drainage Area: 1 ft<sup>2</sup>

Comments: Below grade cleanout in front lawn has a broken cap.

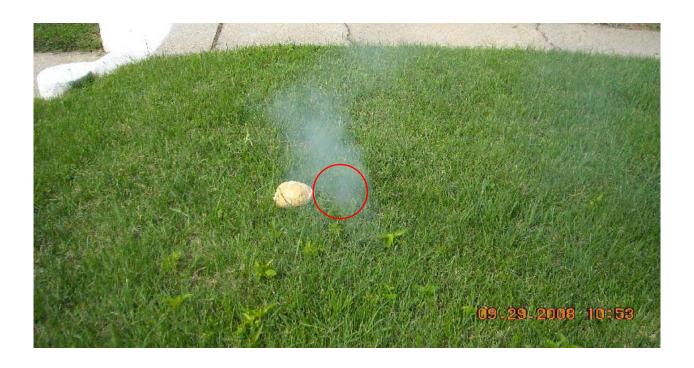
Photograph No: OB07-P01 Filename: S1039-003\_OB07-P01.jpg

Location: 07 Yard - Front Severity: 03 Moderate Drainage Area: 1 ft<sup>2</sup>

Comments: Below grade cleanout in front lawn has a broken cap.

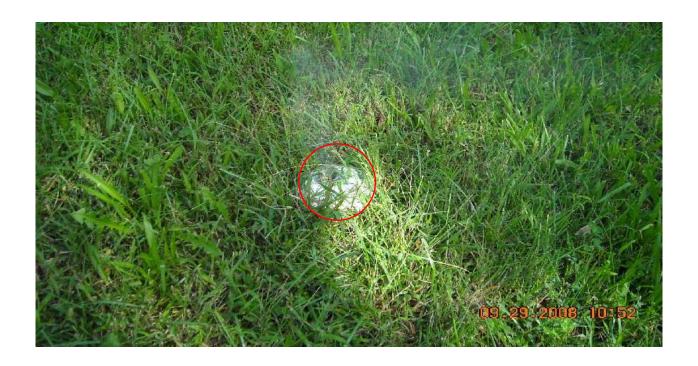
Photograph No: OB08-P01 Filename: S1039-003\_OB08-P01.jpg

Location: 07 Yard - Front Severity: 03 Moderate Drainage Area: 1 ft<sup>2</sup>

Comments: Above grade cleanout in front lawn has a broken cap.

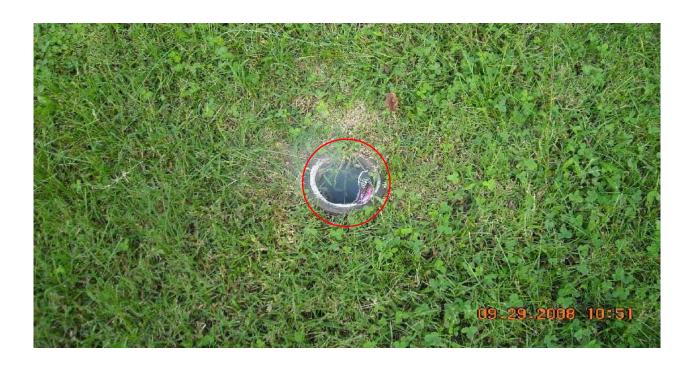
Photograph No: OB09-P01 Filename: S1039-003\_OB09-P01.jpg

Location: 07 Yard - Front Severity: 03 Moderate Drainage Area: 1 ft<sup>2</sup>

Comments: At-grade cleanout in front lawn is missing a cap.
